# **Signal Warrant Analysis**

# **Roosevelt Avenue and Roosevelt Terrace**

in the City of Springfield, MA

October 2023

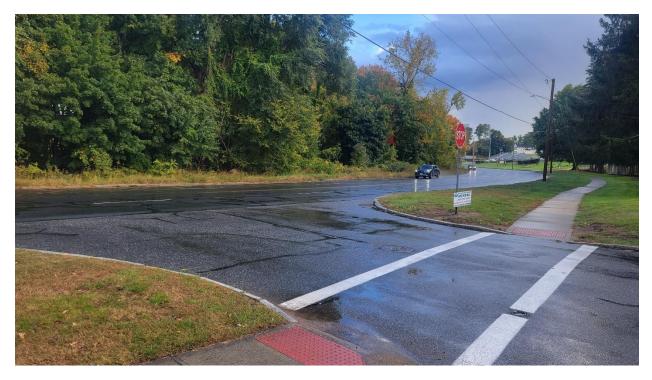
#### Figure 2: View from the Northwest Corner of the Intersection

Roosevelt Terrace intersects Roosevelt Avenue along a horizontal curve. Sidewalks are provided on the north side of Roosevelt Terrace and the west side of Roosevelt Avenue. Granite curbing is provided in the vicinity of the intersection. A double line crosswalk is located across the Roosevelt Terrace approach. The curbing, the pavement, and the pavement markings are all in good condition and seem to have been recently upgraded.

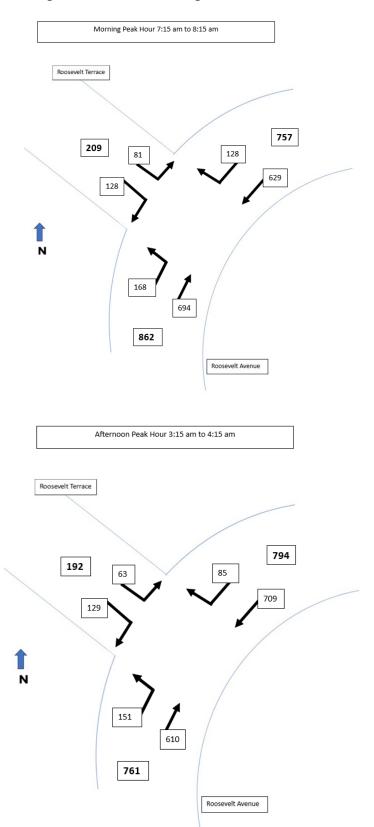
Figure 3: Peak Hour Turning Movement Counts

Almost 20% of northbound traffic along Roosevelt Avenue makes a left turn into Roosevelt Terrace during both the morning and afternoon peak hours. Queuing of more than three vehicles with long wait times were observed for the left lane of this approach during data collection. Driver frustration led to a few close calls and near crashes as observed by PVPC staff. Furthermore, PVPC staff also observed longer wait times for vehicles attempting to exit Roosevelt Terrace.

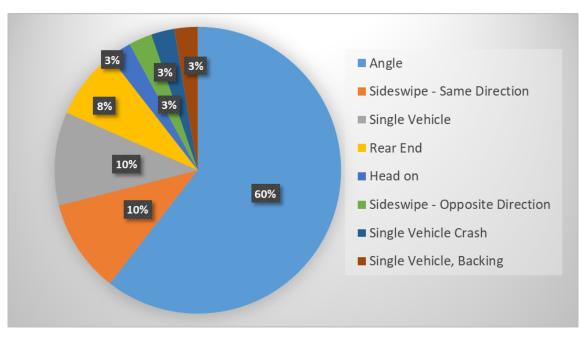
Figure 5: Roadway Surface Condition

Figures 4 and 5 depict the distribution of manner of collision and roadway conditions during which these crashes occurred. Almost 60% of crashes were angle type collisions. More than 10% were sideswipe crashes that occurred because of longer delays for left turning vehicles experienced along Roosevelt Avenue. These are crashes that can be addressed by the installation of a traffic signal.

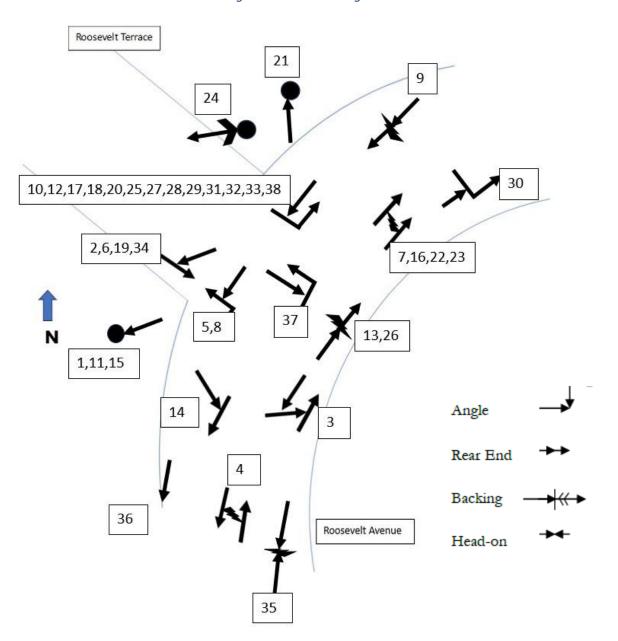
Figure 6: Collision Diagram

The collision diagram clearly depicts a predominant pattern of angle type collisions that occurred between the left turning vehicles from the Roosevelt Terrace approach and through moving vehicles from the southbound Roosevelt Avenue approach (13 out of 38 or more than 34%). As observed during the Congestion and Level of Service Analysis, this approach operates at very high delays during the peak hours. These delays contribute to driver frustration and the tendency to take a risk and try to perform the left turns in the absence of adequate gaps.

The second most occurring pattern (4 crashes) was observed along the Roosevelt Avenue northbound approach. These crashes were side swipe collisions between vehicles travelling in the same direction. All of these crashes occurred when a driver attempted to change lanes to avoid waiting behind vehicles that were either stopped or slowing down while trying to perform a left turn into Roosevelt Terrace.

One last notable pattern was of single vehicle crashes along the southwest corner of the intersection. These crashes were a result of a combination of factors from roadway geometry, wet road surface, inadequate nighttime visibility, and higher speeds.

- There are no chevrons along Roosevelt Avenue in either direction. Three single vehicle crashes
  occurred at this location during nighttime, these crashes could potentially be prevented by high
  visibility pole mounted chevrons especially along the southbound approach of Roosevelt
  Avenue.

- 5. Installation of a guard rail along the southwest corner of the intersection along with chevrons would further improve the nighttime visibility and potentially reduce the severity of damage at this location. It is recommended that the City of Springfield consider examining the possibility of installing a guardrail at this location.
