# **Signal Warrant Analysis**

# **Roosevelt Avenue and Roosevelt Terrace**

in the City of Springfield, MA

October 2023

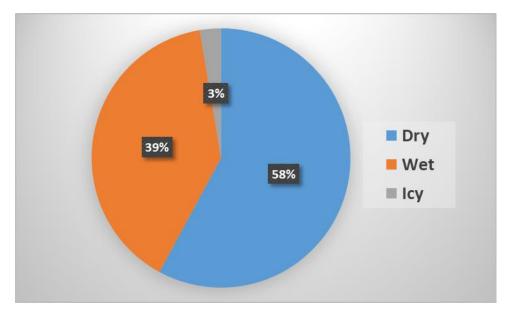
More than 42% of these crashes resulted in personal injury. This number is significant considering the impact of higher severity crashes on both individuals and the economy. The higher speeds along the corridor are one of the contributing factors that increase the severity of a crash.

Figures 4 and 5 depict the distribution of manner of collision and roadway conditions during which these crashes occurred. Almost 60% of crashes were angle type collisions. More than 10% were sideswipe crashes that occurred because of longer delays for left turning vehicles experienced along Roosevelt Avenue. These are crashes that can be addressed by the installation of a traffic signal.
